**ADVENT**  
**VIDEOBEAM 1000A**  
**SERVICE MANUAL CORRECTION SHEETS**  
**(\*\*FOR REPRINTED MANUAL OF 3/17/77)**  
**(\*FOR REPRINTED MANUAL OF 1/1/78)**  
**(No Asterisk – Correction No. 1 After 1/1/78)**

# SERVICE BULLETIN NO. 1

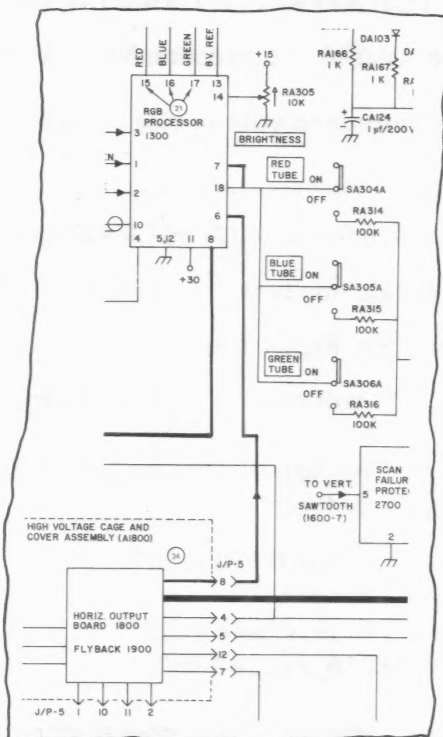
5-1

Add a line from Board 1300 Pin 18 to Board 1300 Pin 7.  
 Add a line from Board 1700 Pin 11 to Board 1300 Pin 8.  
 Add a line from Junction/Plug 5 pin 8 to Board 1300 Pin 6.  
 Delete a line from Junction/Plug 5 pin 8 to Center Tap of SA306A.

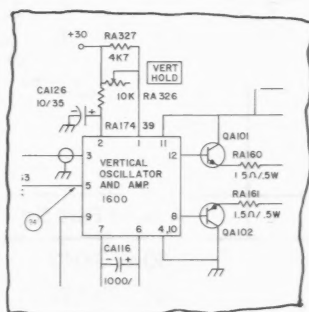
5-1

Add CA126 10  $\mu$ f/35V electrolytic with the following connections:  
 Positive side (+) connected to Board 1600 Pin 2  
 Negative side (-) connected to chassis ground.

Add RA174 39 $\Omega$  1/4W 10% with the following connections:  
 One end connected to Board 1600 Pin 2  
 Other end connected to the 30V supply placing RA174 in series with the 30V supply.

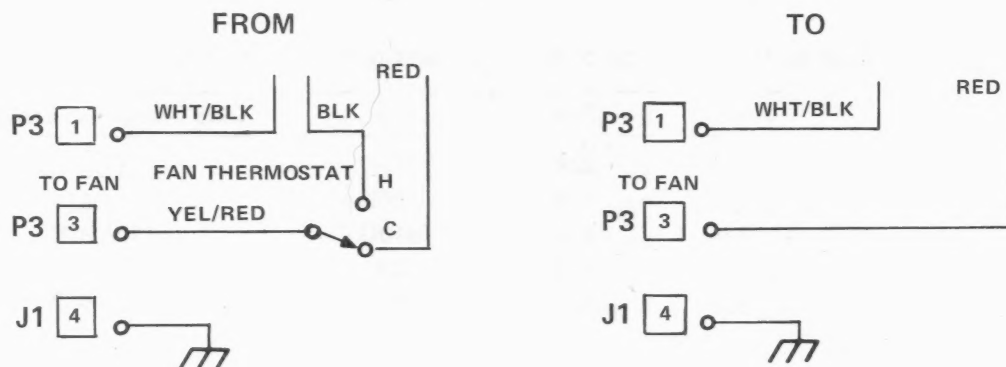
Change the following lines on the schematic drawing as shown:

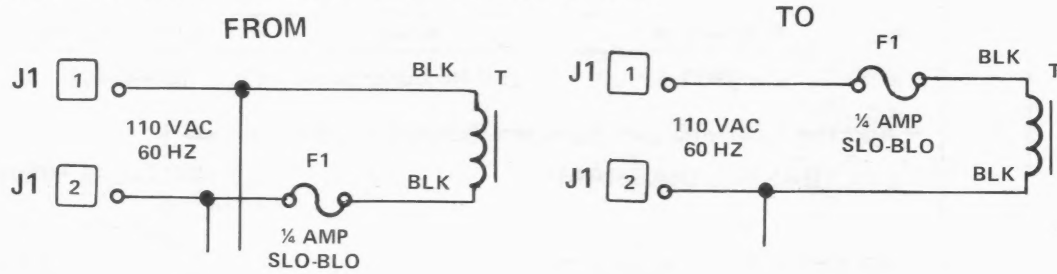
5-4  
and  
5-4A

Fuse, F1, ¼AMP.-slow blow. Date effective 2/27/78.

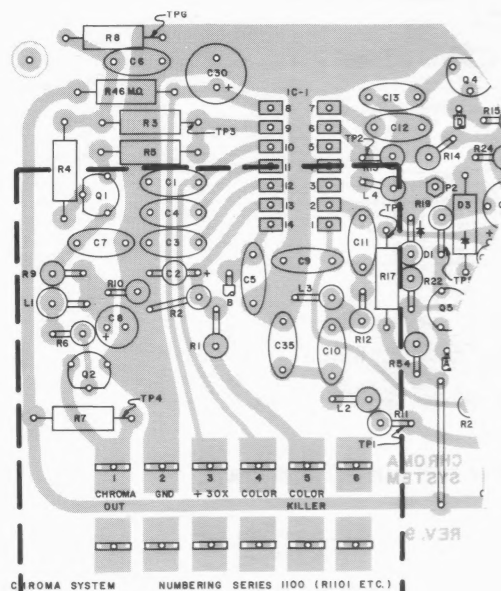
Changes in area "A" are as follows:  
10K deleted. C5 and C9 relocated to component side of board.

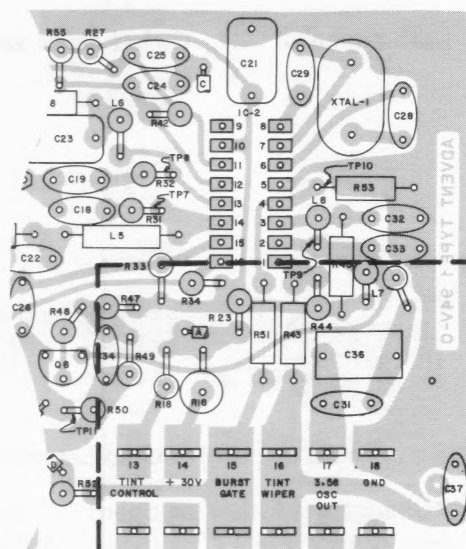
Changes in area "B" are as follows:  
C35 relabeled C37. C31 changes value. C36 is added.

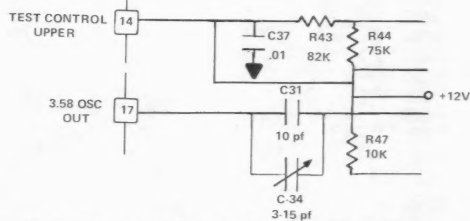
5-20 \*\* C-35 relabeled C37. C31 changes value, C36 is added.

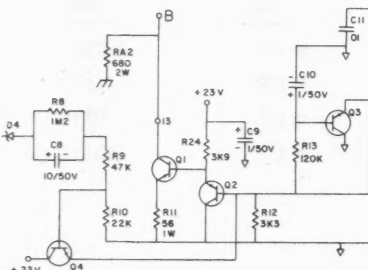
\*\* Delete diode D5

\*\* Add Transistor Q4 as shown

\* R21 from 82K to 75K Effective 11/12/75

\* C4 from 0.39 to 0.33 Effective 3/17/76

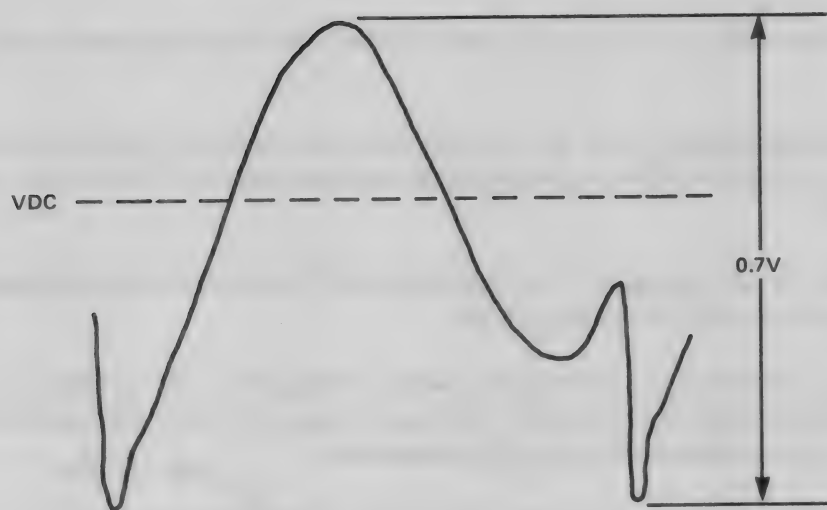
WAVEFORM A

Waveform "C" is shown as the most unstable and incorrect waveform. To go from waveform "C" to waveform "A" you would have to rotate the L2 slug in a clockwise direction.
